07/19/89 United Airlines

Report Number	NTSB/AAR-90/06
Access Number	PB90-910406
Report Title	United Airlines Flight 232, McDonnell Douglas DC-10-10, Sioux Gateway Airport, Sioux City, Iowa, July 19, 1989
Report Date	November 1, 1990
Organization Name	National Transportation Safety Board Office of Aviation Safety Washington, D.C. 20594
WUN	5158D
Sponsor Name	NATIONAL TRANSPORTATION SAFETY BOARD Washington, D.C. 20594
Report Type	Aircraft Accident Report July 19, 1989
Distribution Status	This document is available to the public through the National Technical Information Service, Springfield, Virginia 22161
Report Class	UNCLASSIFIED
Pg Class	UNCLASSIFIED
Pages	126
Abstract	<p>This report explains the crash of a United Airlines McDonnell Douglas DC-10-10 in Sioux City, Iowa, on July 19, 1989. The safety issues discussed in the report are engine fan rotor assembly design, certification, manufacturing, and inspection; maintenance and inspection of engine fan rotor assemblies; hydraulic flight control system design, certification, and protection from uncontained engine debris; cabin safety, including infant restraint systems; and aircraft rescue and firefighting facilities. Safety recomm

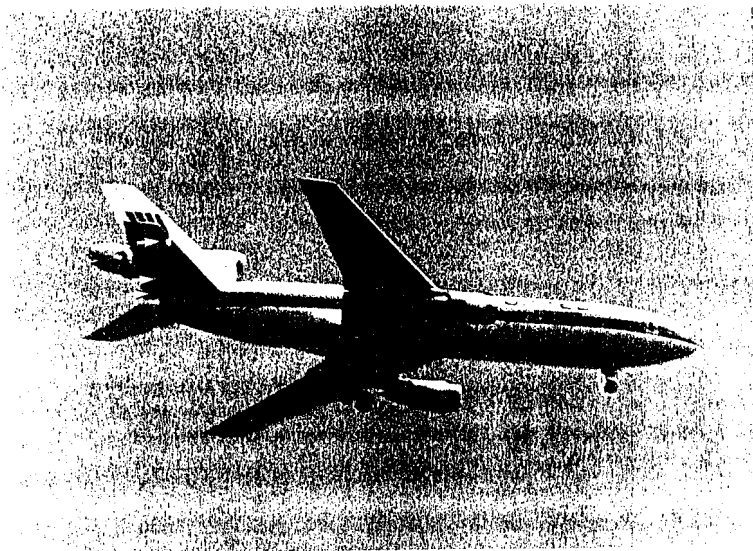
Figure 3.--Photo (C. Zellmer) taken while flight 232 was approaching Sioux Gateway Airport.

Photographs of the airplane were taken by observers on the ground during its final approach to Sioux Gateway Airport. They showed that the No. 2 engine fan cowl and the fuselage tail cone were missing. The remainder of the No. 2 engine appeared intact. Postcrash examination of the wreckage revealed that the No. 2 engine fan rotor components forward of the fan forward shaft, as well as part of the shaft, had separated from the engine in flight. (See [figure 3](#), [figure 4](#), [figure 5](#)).

Arrows indicate damage to the right horizontal stabilizer. It is also evident that the No. 2 engine fan cowl door and the tail cone are missing.

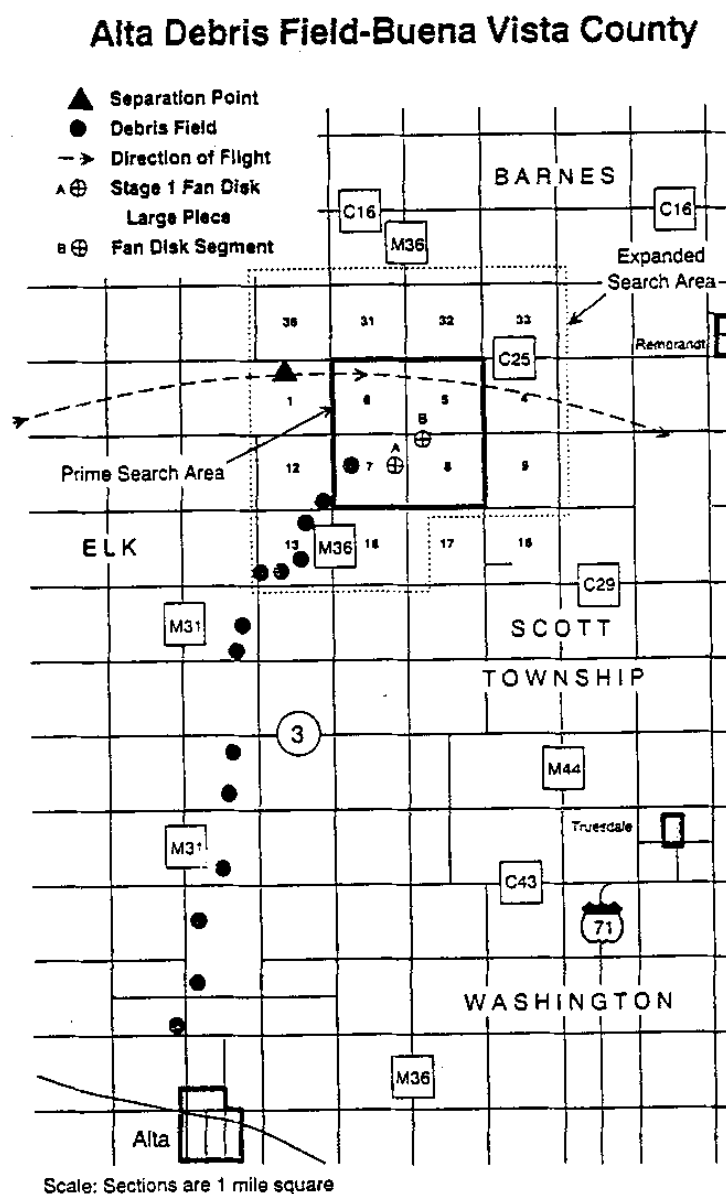
Figure 11. --Trajectory information/Alta debris field.

Also found near Alta soon after the accident were parts of the tail engine adapter assembly, consisting of adapter ring and bellmouth assemblies, an anti-ice pneumatic tube, a starter air tube, three cowl hold-open rods, two hydraulic system accumulators from the No. 2 engine-driven hydraulic pumps, fan blade fragments, two pieces of insulated metal braid-covered hydraulic hose clamped together, and a segment of aluminum material broken out of the large structural "banjo" forging from the airplane inlet duct structure.

About 3 months after the accident, parts of the No. 2 engine fan disk were found in farm fields near Alta. There were two sections that constituted nearly the entire disk, each with fan blade segments attached. These parts were initially taken to the GEAE facility in Evandale, Ohio, for examination under the direction of the Safety Board. The small segment was later transported to the NTSB Materials Laboratory in Washington for further evaluation. (See section 1.16, Tests and Research).

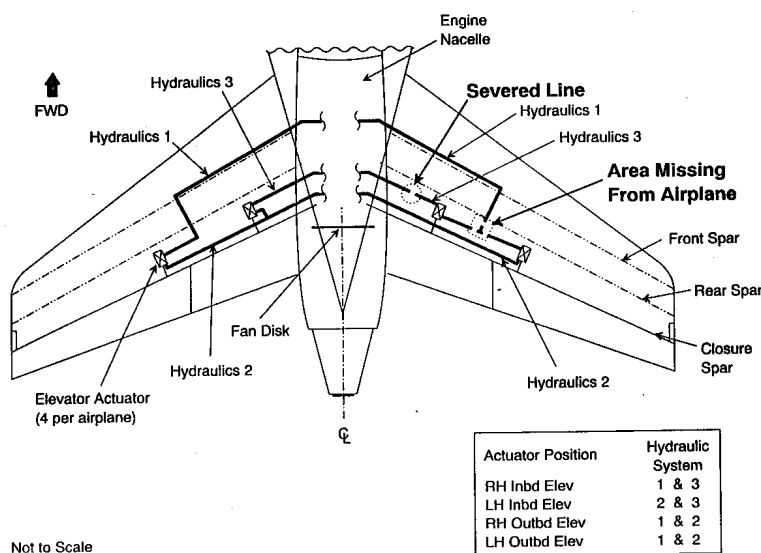
Figure 14.--N1819U, planform of horizontal stabilizer hydraulic system damage.

Right Horizontal Stabilizer Damage.--The outboard elevator had been broken and separated from the outer section of the horizontal stabilizer between the actuator and the inboard damper hinges. Forward of that, the section was broken and had separated on a line parallel to the aircraft centerline from just outboard of the actuator. This section was about 16 feet long. The stabilizer had also separated along a line from between the mid- and inner hinges of the inboard elevator parallel with the aircraft centerline to the leading edge of the stabilizer.

There were three large holes found in the right stabilizer. One hole, located at the outboard leading edge and oriented generally spanwise, extended aft to the front spar; this hole was one of the damaged areas visible in the in-flight photograph taken during the airplane's approach to the airport. Considerable effort was expended to identify the source of this damage; the damage has dimensions similar to the size of the large piece of the fan disk and blades. However, no positive match could be made. A second hole seen in the in-flight photograph was forward of the inboard elevator. Flight control hydraulic components are in this area. The exact size and shape of the hole could not be determined because of damage from the ground impact and the breakaway of the stabilizer section outboard of the inboard elevator actuator. A third hole was in the inboard elevator; there are no critical components within this structure.

During reconstruction of the empennage, it was noted that a portion of the right horizontal stabilizer was not recovered at the Sioux City Airport. A photograph taken from the ground prior to impact shows that this section was missing before impact. The missing area contained the No. 1 hydraulic system tubing that supplies hydraulic fluid to the right inboard and outboard elevator actuators. (See [figure 13](#) and [figure 14](#)).

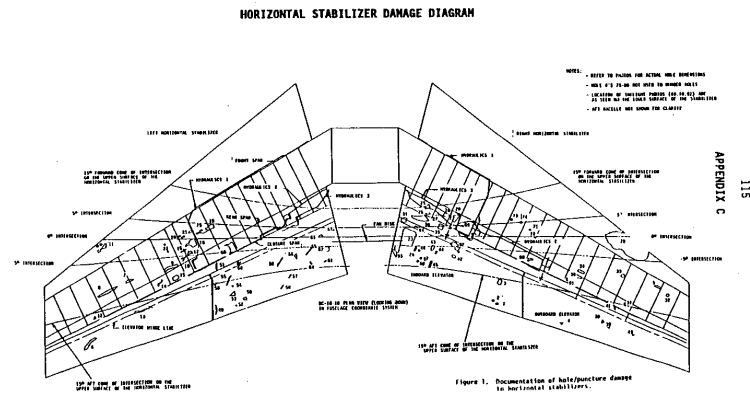
HORIZONTAL STABILIZER DAMAGE DIAGRAM

Four punctures on the vertical stabilizer were noted as probable fragment damage prior to ground impact. Documentation of hole/puncture damage to the horizontal stabilizers is contained in Appendix C. There were 79 punctures recorded from fragment damage and one large hole, about the same size as the large piece of recovered fan disk. The flight control surfaces were recovered in the aircraft wreckage and had varying degrees of damage that could have occurred before or after impact.

The remaining smaller holes were examined to determine if they had been caused by engine hardware and to verify elements of the aircraft control systems that had been damaged. The diagram shown in appendix C was prepared.
